Comparison of methods of monitoring structure deformations based on tests of a flat plate slab

Abstract: This work includes a comparison of the methods of monitoring the deformations of a structure on the example of a flat plate slab test. Classic ESG (electrofusion strain gauges) and modern DFOS (distributed fiber optic sensors) were compared. During the research, both types of sensors were used on some of the reinforcing bars. The study aims to indicate the differences between the compared monitoring methods, both in terms of the obtained results and their utility values.

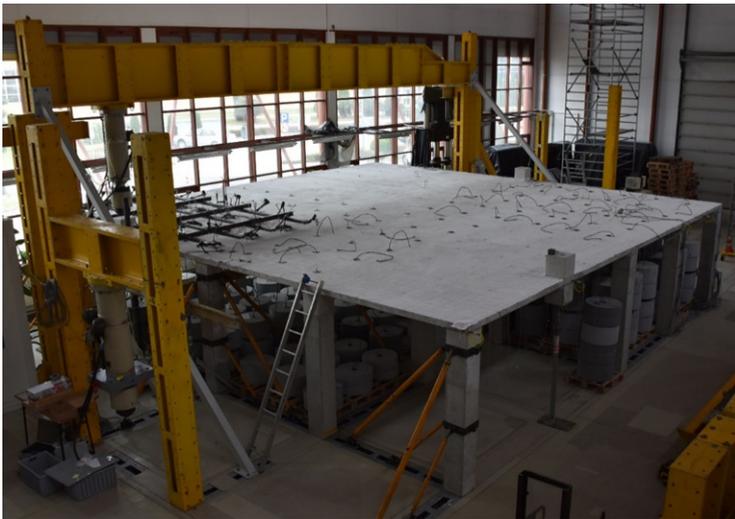
The tested model presented in fig. 1, was a sixteen-section flat plate slab, reflecting the work of the real structure.

Fig. 1. View of the research model. *Source:* author

The tested model was made on a scale of 1:3 so that it replicated the real object as accurately as possible. The model assumed a support spacing of 2.4 m, which corresponds to a ceiling span of 7.2 m commonly used in construction in scale 1:3. The slab thickness was assumed to be 80 mm and the dimension of prefabricated columns 300x300 mm. The total dimension of the tested slab was 9.9 x 9.9 m. The research model of the slab was monolithic. The upper part of the columns was monolithized with the slab plate in the laboratory – fig. 2. The slab reinforcement was designed assuming the ceiling loads had the following values: permanent load $g_k = 3 \text{ kN/m}^2$ and variable load $q_k = 3 \text{ kN/m}^2$. Different bonding reinforcement was used in the tested element to create a secondary load-bearing structure in the event of local damage to the edge columns.

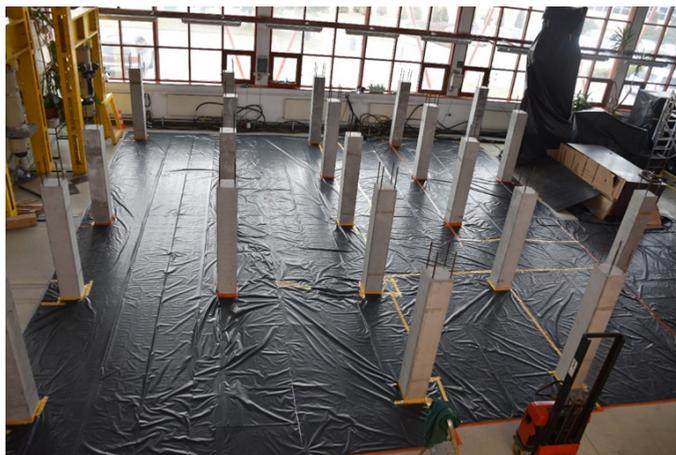
Fig. 2. Prefabricated reinforced concrete columns attached to the strength floor. *Source:* author

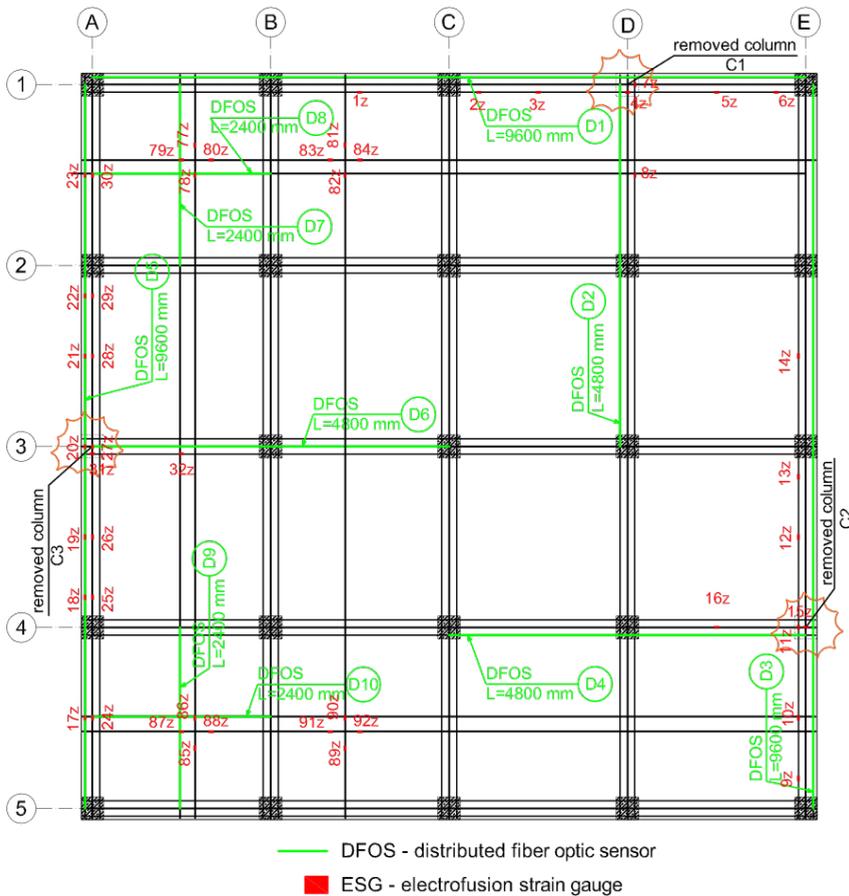
Fig. 3. Strain gauges arrangement scheme on the bottom reinforcement. *Source:* author

During the conducted studies, electrofusion strain gauges and fiberoptic strain gauges were used to measure strains. In the tested element, more than 100 electrofusion strain gauges were glued onto reinforcing steel and about 50 onto concrete. 19 fiberoptic strain gauges were also glued onto reinforcing steel and 4 onto concrete. Fig. 3 and fig. 4 show a strain gauges arrangement scheme used only on reinforcing steel.

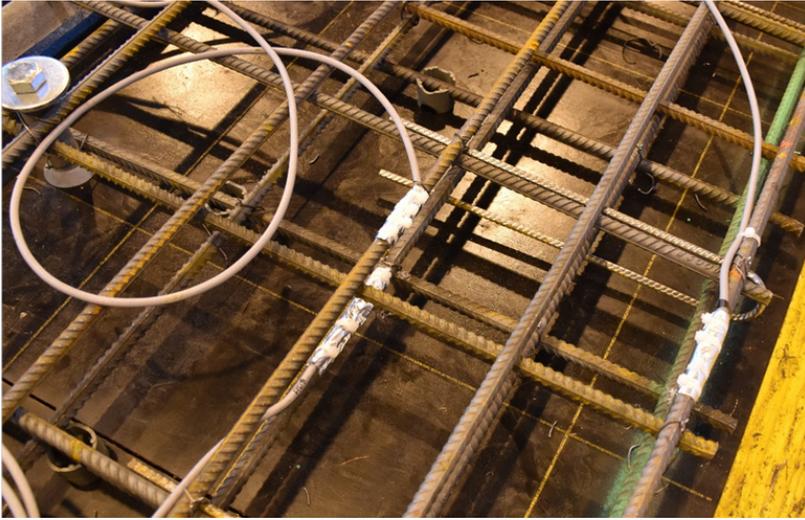
Fig. 5. View of electrofusion strain gauges glued to the reinforcement. *Source:* author

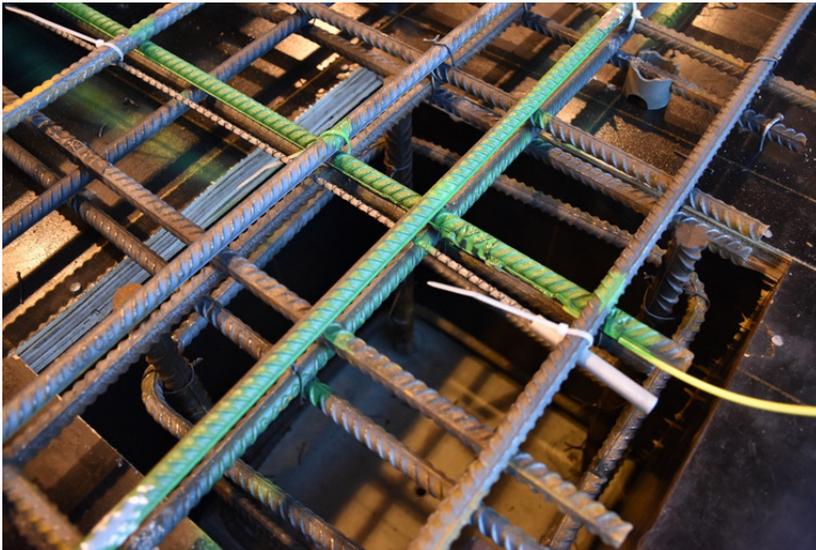
Fig. 6. View of fibre optic strain gauge glued to the reinforcement. *Source:* author

Another group of sensors used to measure strains are optical fiber strain gauges, in which the basic element is a standard optical fiber, a thin glass fiber transmitting light in its core. DFOS (distributed fiber optic sensors) were used in the conducted research – fig. 6.

The installation and recording of results from fiberoptic sensors were handled by an external company – SHM System. SM 9/125, OFS, ITU-G657.A1 fiber sensors were glued to the longitudinal ribs of rebars with a thin layer of epoxy resin. Strain results were recorded using OBR4600 reflectometer manufactured by LUNA Technologies in the unit:

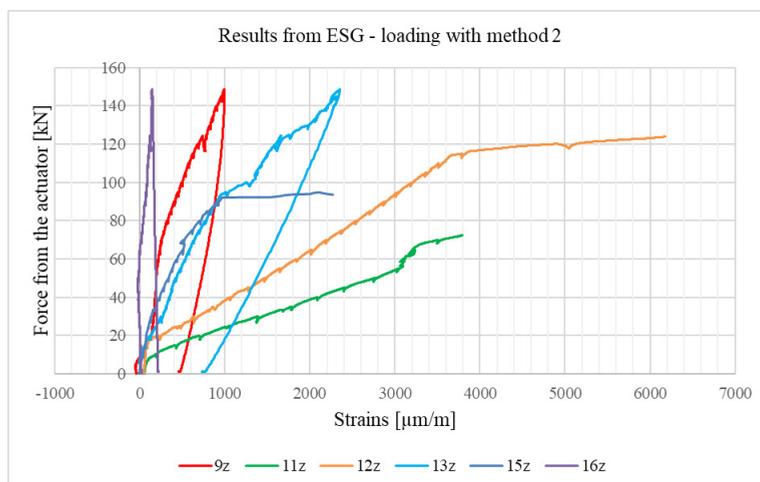
Fig. 7. Results from electrofusion strain gauges. Strain gauges glued to different bars of the bottom reinforcement – loading method 2. *Source:* author

As can be seen, three strain gauges broke during the tests. The 15z strain gauge was damaged with relatively small strains amounting to only 0.1%, while the 11z and 12z strain gauges with strains of about 0.4%, which can be equated with reaching the yield point by the reinforcing steel. The failure mechanism at 0.4% strains presented in fig. 7. was typical for most strain gauges used in the research.

Examples of the strain measuring results of reinforcing steel with electrofusion strain gauges are shown in fig. 7. These are the results of several measurement points located on the bottom reinforcement, located in the tested slab.

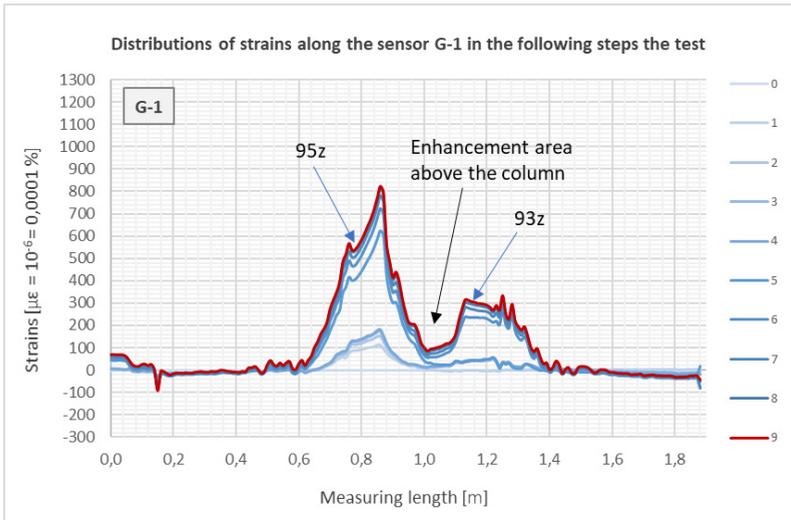
Fig. 8. Results from the DFOS-G1 – loading method 1. *Source:* author

Fig. 9 shows the results of strain measurements for the selected two points placed on the rebar, obtained with electrofusion strain gauges. On the other hand, fig. 8. shows the results of strains measurements with the use of fiberoptic sensors. Obtained results are for the entire length of the tested reinforcing bar, the same one in which the strain gauges shown in fig. 9. were placed. The result of deformation is presented depending on 9 load stages, determined by the suspension of concrete weights simulating permanent and variable loads (method 1).

As can be seen, the strains obtained, e.g., step 9, are different depending on the measurement technique. From electrofusion strain gauges, the strains for points 93z and 95z are respectively: approximately 380 $\mu\text{m/m}$ and 200 $\mu\text{m/m}$, while those obtained from fiberoptic sensors are larger and amount to 95z = 530 $\mu\text{m/m}$, 93z = 300 $\mu\text{m/m}$. When analysing the strains of the entire length of the bar, more interesting processes can be noticed, such as a decrease

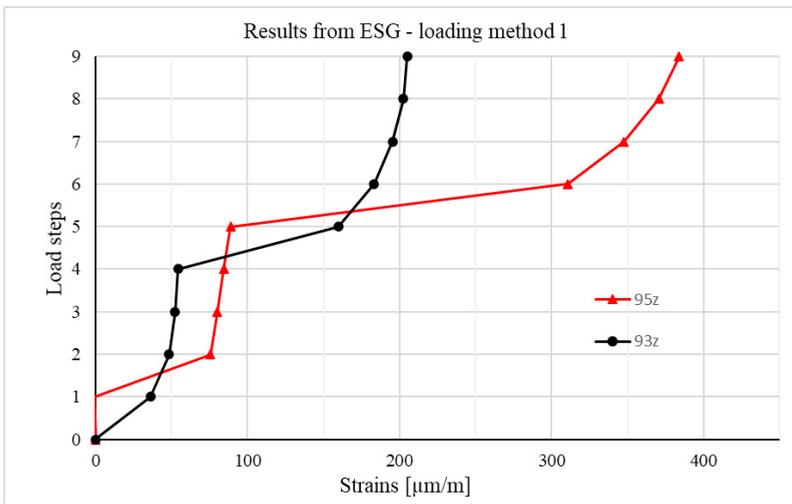
Fig. 9. Results from the 93z and 95z electrofusion strain gauge. Strain gauges on the top reinforcement bar at a distance of 75 cm and 115 cm from the beginning of the bar (5 cm behind the face of the column) – loading method 1. *Source:* author

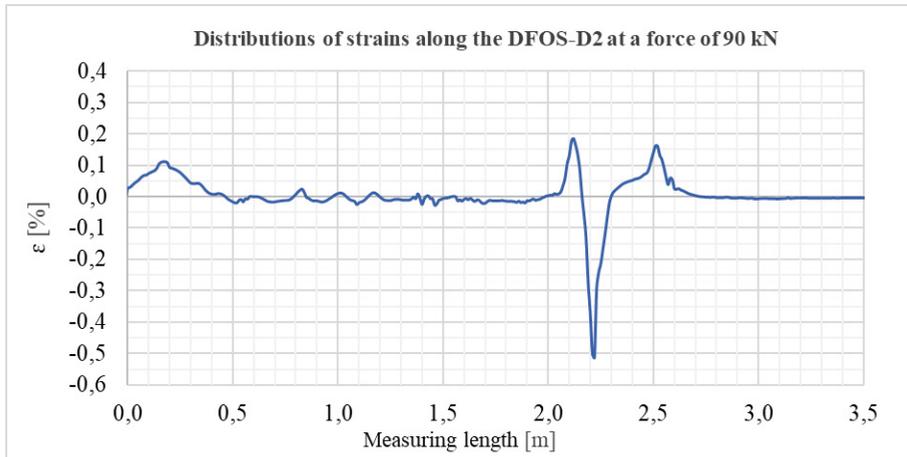
Fig. 10. Distribution of strains on the bottom reinforcement bar obtained from the DFOS-D2 sensor with an actuator load of 90 kN. *Source:* author

Continuous measurement allows you to see differences in the deformability of bars, which seem to be the same. This process was observed during tests carried out on three bars perpendicular to the removed supports. Fig. 10, fig. 11, and fig. 12 show strains diagrams obtained from fiber optic sensors placed on the analysed reinforcement bars during a load of 90 kN.

The charts presented above allow to read the tensile strains in the place where the actuator is applied, amounting to approximately 0.1% in each case. The situation is different over the support. In the case of the DFOS-D4 sensor, the expected deformation course of almost 0.4% can be seen. However, the DFOS-D2 sensor shows a completely different course. The rapid jump of strains in the compression direction to the value of -0.5% could be caused by the local influence of transverse reinforcement or the local pressure of the aggregate against the sensor. The local nature of this process highlights the fact strains before and after the “jump” amount to approximately 0.4% – similar to the DFOS-D4 sensor. The strains above the support obtained from the sensor DFOS-D6 are significantly lower. This seemingly insignificant fact had an impact on the change in the strains of the DFOS-D6 bar in relation to DFOS-D2 and DFOS-D4. During the tests, the reinforced concrete central column was removed and replaced with a steel column loosely connected to the slab. The lack of a rigid connection enabled the slab to rotate over the support and, as a result, the measured deformation of the bar was 4 times smaller.

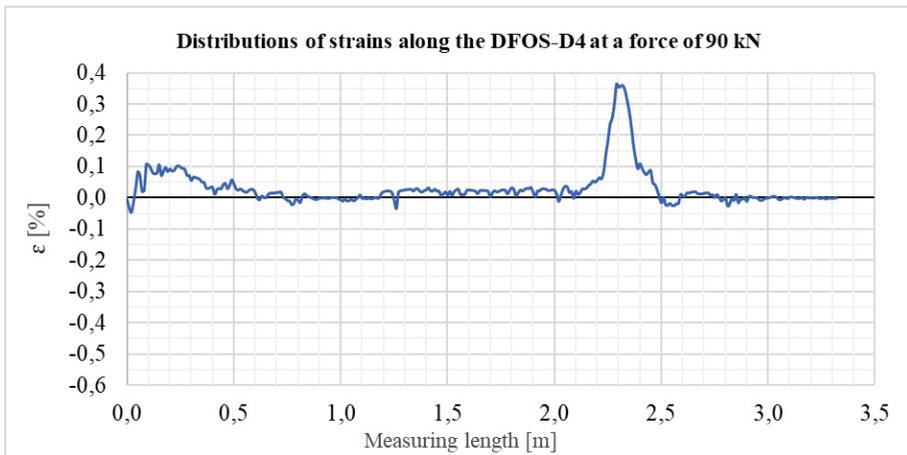
Fig. 11. Distribution of strains on the bottom reinforcement bar obtained from the DFOS-D4 sensor with an actuator load of 90 kN. *Source:* author

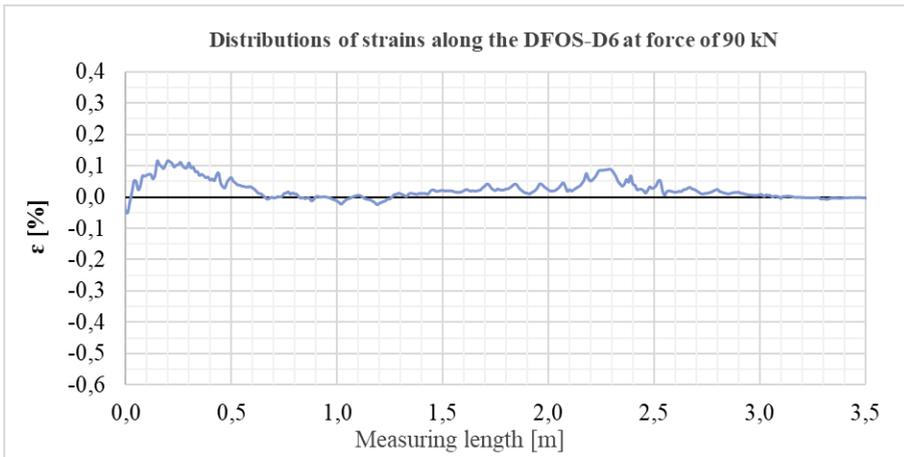
Fig. 12. Distribution of strains on the bottom reinforcement bar obtained from the DFOS-D6 sensor with an actuator load of 90 kN. *Source:* author

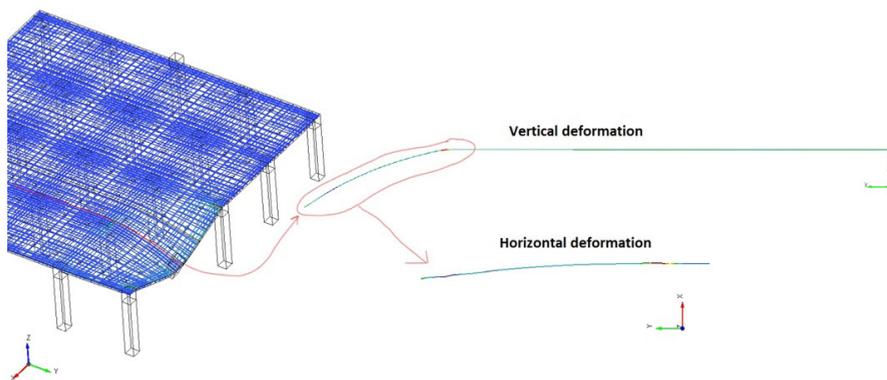
Fig. 13. Images of reinforcing bar deformation obtained from the numerical model using the ATENA program.
Source: author

As shown in the figure, the reinforcement bars have undergone deformations along the bar axis as well as lateral deformations. This means that the tested element works in a complex state of stress. Therefore, electrofusion strain gauges adapted to work in the uniaxial state of stress can provide erroneous results. Conducted tests confirmed that the results obtained in many cases were defective and strain gauges were destroyed at the limit strain values lower than those provided by the manufacturer. This process was not observed in the case of fiberoptic strain gauges. Conducted research and obtained results have shown one more important aspect that should be taken into account when planning the measurements – the place on the bar to which the fiberoptic strain gauge will be glued. In conducted research, the fiberoptic strain gauges were glued onto the longitudinal ribs of the reinforcing bars and then placed in the plate in such a way, that the strain gauge was located on the side edge. During formwork and concrete pouring, it is possible to rotate the bar around its axis and the glued sensor will be located on the lower or upper edge, and this may have a significant impact on obtained results and their comparison.

To analyse the processes that were impossible to capture directly during the research, a numerical model of the tested flat plate slab was created. The numerical model was devised in the ATENA program and validated based on the results obtained from experimental measurements. Fig. 13 shows the deformation of reinforcement bars during tests, obtained from numerical simulations.
