# Comparative analysis of the inventory process using manual measurements and laser scanning

**Abstract:** Laser scanning allows the acquiring of spatial data about existing objects. It is used as a modern inventory technique, most often in the creation of archival or conservation documentation. It gives the opportunity to obtain a very large amount of spatial data of the facility thus helping to improve operations in the field of conservation but also reduces the margin of error in the inventory and then design documentation. It is useful due to the growing BIM technology, through which three-dimensional models of existing objects of various scales are obtained. This article presents research comparing the traditional measurement method and the modern one with the use of a laser scanner. The research is a compilation of the duration of architectural inventory techniques as well as the accuracy of the measurements made and of the following architectural drawings. The result of the research is a relative percentage ratio showing the acceleration of inventory works with a simple construction object using modern assistive techniques compared to the traditional method.

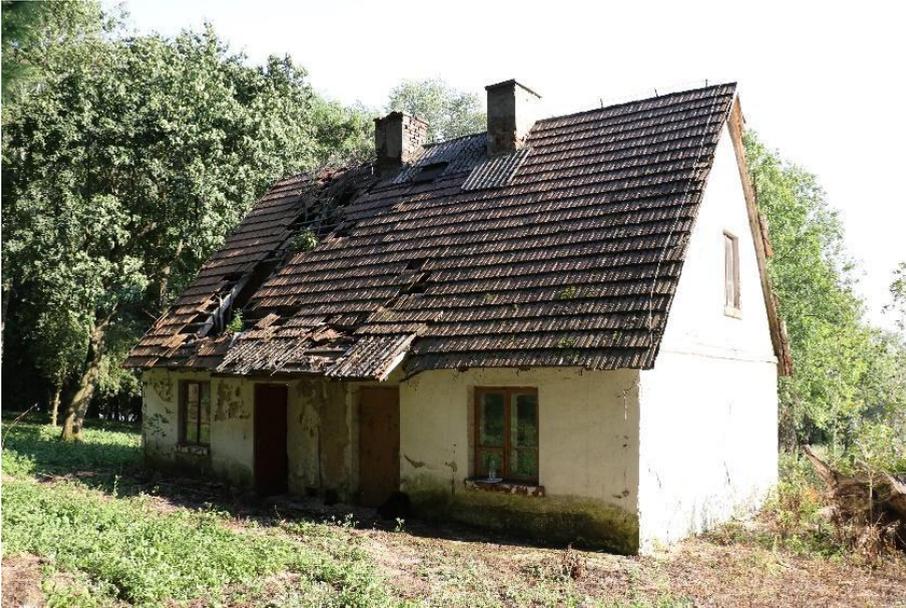
Fig. 1. Building covered by the study, Snopków 102 - photo by the author

The object undergoing inventory works is a residential building located on the premises of the palace and park in Snopków in the commune of Jastków (Fig. 1). It has a simple body with a gabled roof, two symmetrically located northern entrances, windows on each external wall and additionally two roof windows on the south side. Small ventilation openings to the basement from the front, located symmetrically at ground level. It is a two-story building made of solid brick with wooden window and door joinery, with no visible decorations, both outside and inside the building.

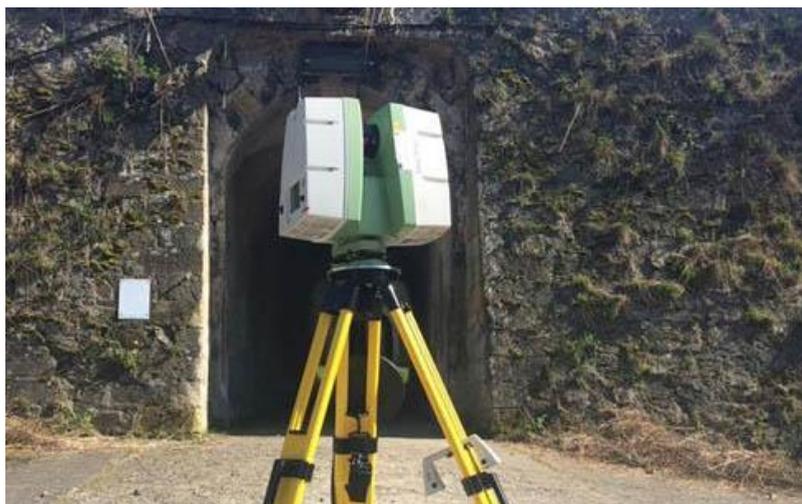
Fig. 3. Leica C10 laser – photo by author

Basic available equipment used during architectural inventory was used for research on the site. In the traditional method, a laser rangefinder and measuring tape were used (Fig. 2). In the case of laser technology, the Leica C10 laser scanner was used (Fig. 3) [11]. The research method focused on the basic measurements carried out on this type of buildings in traditional and laser inventory (Table 1). The aim was to create a comprehensive measurement documentation taking into account the dimensioning of the building's facade, indoor enclosures, roof truss, staircase and finally marking the damage in the object's structure.
